Model (s) affected: RV-3

PURPOSE: To specify airframe alterations required on VAN'S AIRCRAFT RV-3 airplanes for re-designation to model RV-3A for the purpose of exempting them from the limitations dictated by FAA GENOT RWA 1/40 SVC B, dated Mar. 24, 1981. Said GENOT requires that airworthiness certificates of all RV-3 aircraft be suspended until new ones are issued which prohibit aerobatics. Said aerobatic prohibition is permanent, and will be applicable to all aircraft designated VAN'S AIRCRAFT RV-3.

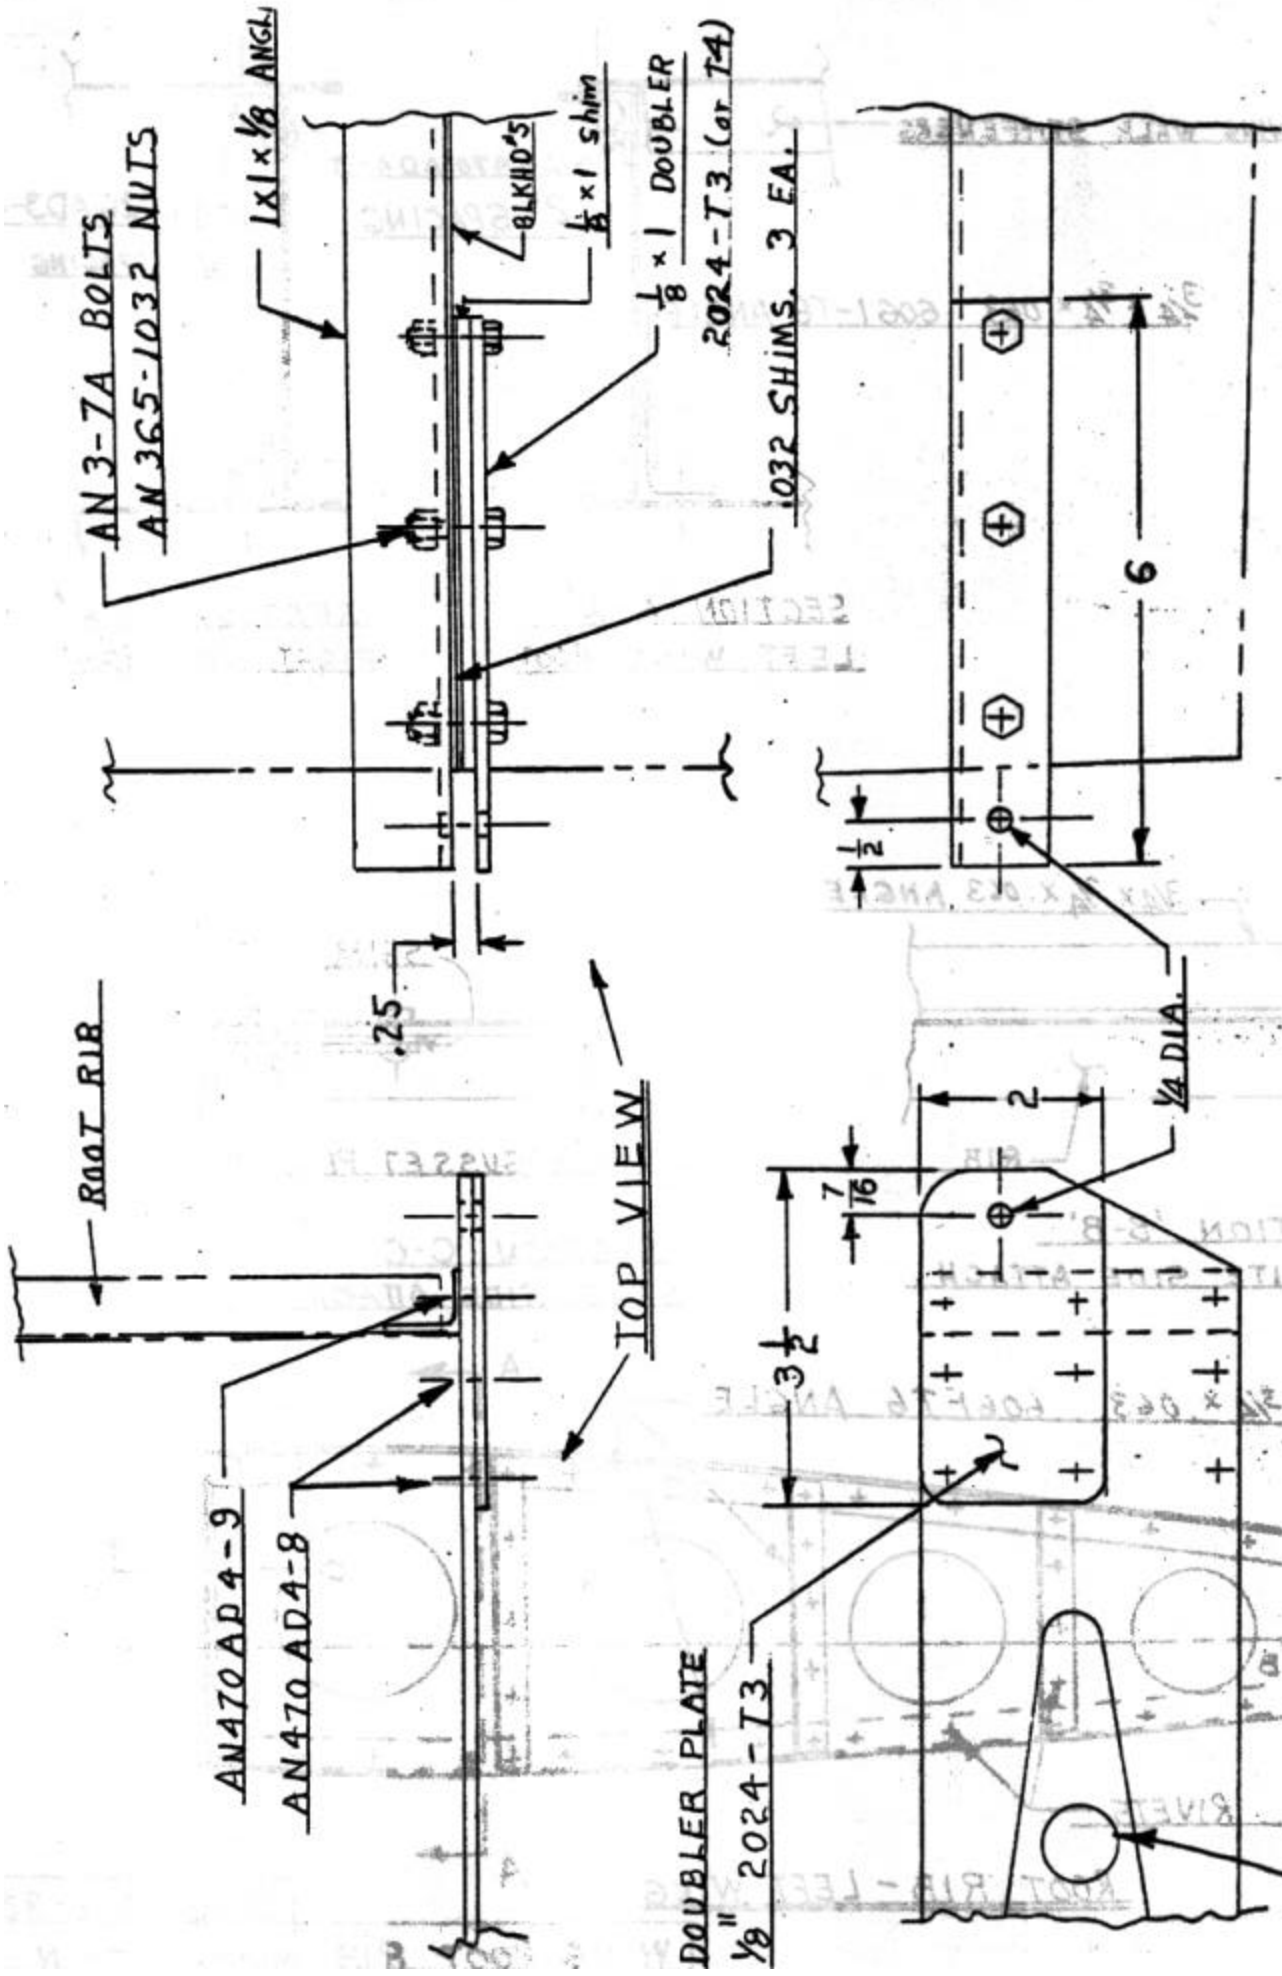
REAR SPAR ATTACH MODIFICATION
MODEL: RV-3/RV-3A DR: R. YANGRUSVEI

CN-1-1 details rear spar and center section modifications for RV-3s built from plans and kits supplied before Sept. 1980. These are distinguished by rear spar center sections of 1 x 1 x 1/8" 6061-T6 angle.

This modification is detailed on drawings CN-1-1 and CN-1-3, and its primary purpose is to increase the bearing area of the rear spar bolt attach, and to place this bolt in double shear rather than single shear as per the original RV-3 plans. It is also intended to emphasize the importance of, and help assure that proper bolt edge distance is maintained. The plans specify a minimum edge distance of 7/16". When the spar doubler plate is installed, the original hole edge distance can be as little as 3/8 inch, providing that the doubler has the specified edge distance of 1/2 inch. Any member in which the hole edge distance is less than 3/8 inch must be replaced before proceeding with the modification.

RV-3 plans and kits supplied before Sept. 1981 have a rear spar center section made of 1 x 1 x 1/8 6061-T6 aluminum angle. This modification, per CN-1-1, requires that a doubler plate be added to the outboard ends of the center section. For completed airplanes, accomplishing this will require that part of the seat skin be drilled free and bent up for access, and that a larger hole be cut in the fuselage skin for this member. The three outboard most rivets on each side are to be drilled out and replaced by AN3 bolts. The reason for this is that they are both easier to replace and stronger than the original rivets. Along with this, the rear spar root plate must have a doubler plate riveted to it.

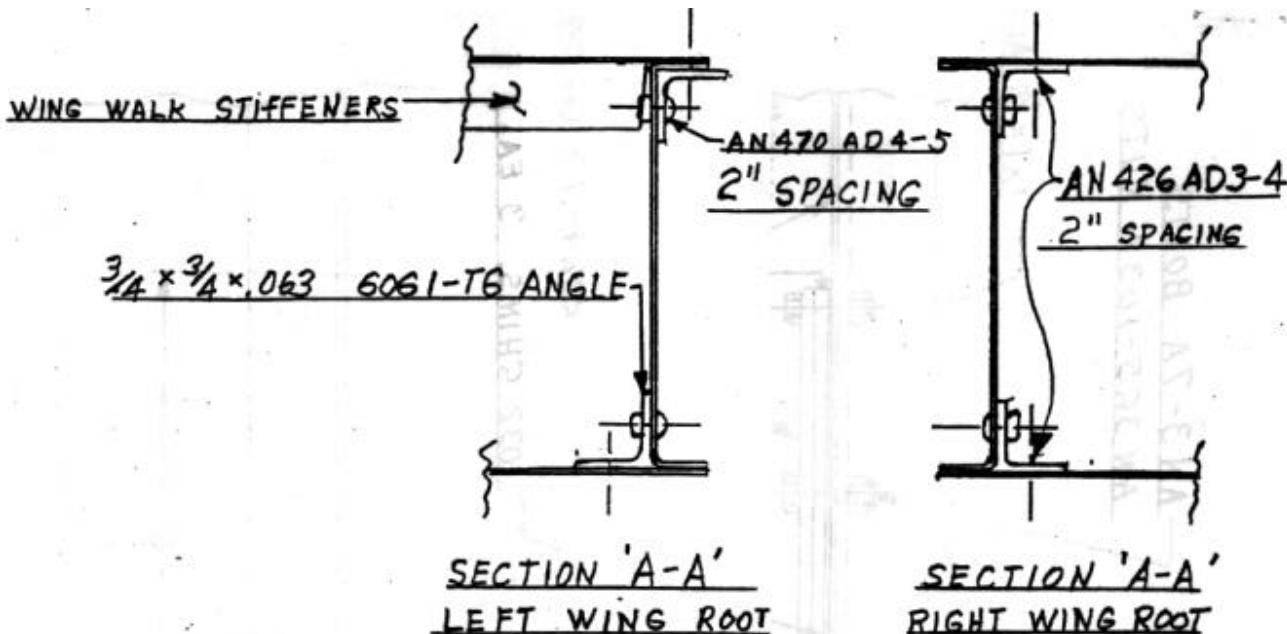
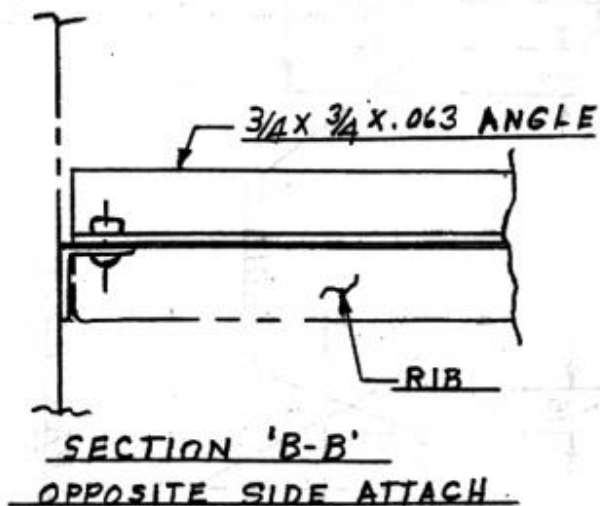
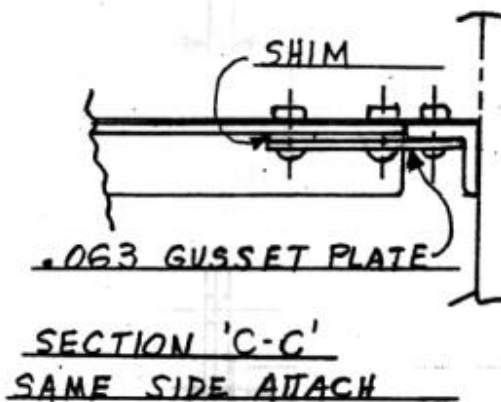
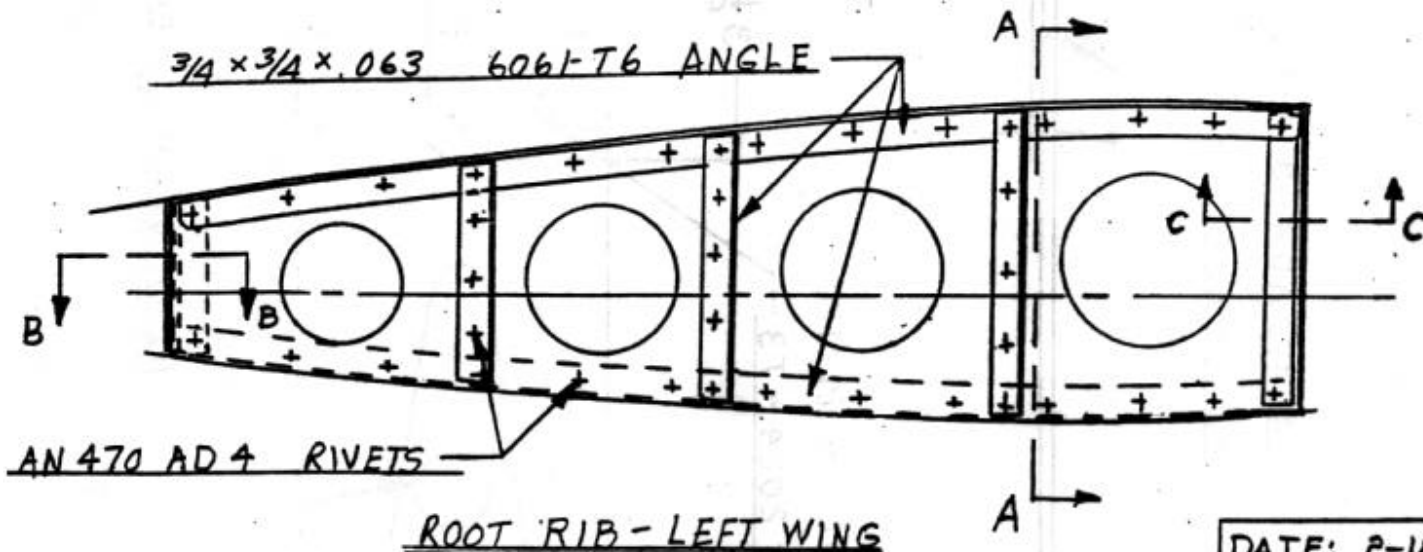
VANS AIRCRAFT DWG: CN-1-2

CN-1-2 details wing root rib modifications which can be performed on all RV-3s regardless of root rib thickness or degree of completion, including finished airplanes. Root ribs of pre-Sept. 1980 plans and kits were .020" thick, whereas later ones were .032" thick.

The torsional strength of the wing is increased by adding angles or bars to the upper portions of the root rib as shown on CN-1-2 and CN-1-4, or by adding additional ribs near the root as shown on CN-1-4. Both methods of root rib reinforcement are applicable to completed wing pannels because all required work can be performed without removing any wing skin. Use of the bars is probably the easier method because their installation does not require the removal of any skin rivets and because they are to be riveted to the exposed side of the rib. Use of the angles is more involved but does offer a neater, more structurally efficient modification. Whichever method is selected, one very important point is that the angles or bars be securely riveted to the main and rear spars. This is done through the root rib attach angle on the main spar, and a similar angle to be added to the rear spar during this modification. When using angle reinforcements, refer to Section A-A' drawings for positioning. Wing walk stiffeners dictate that the angle on the upper portion of the left root rib be attached to the inboard side of the rib web. In some instances where the reinforcement angles and spar angles do not provide lap joints, gusset plates as shown in Section C-C' must be used. When bar reinforcements are used on the side of the rib web with raised web stiffener rings, the bar is to be riveted to the web at all contact points; the high points of the stiffener rings.

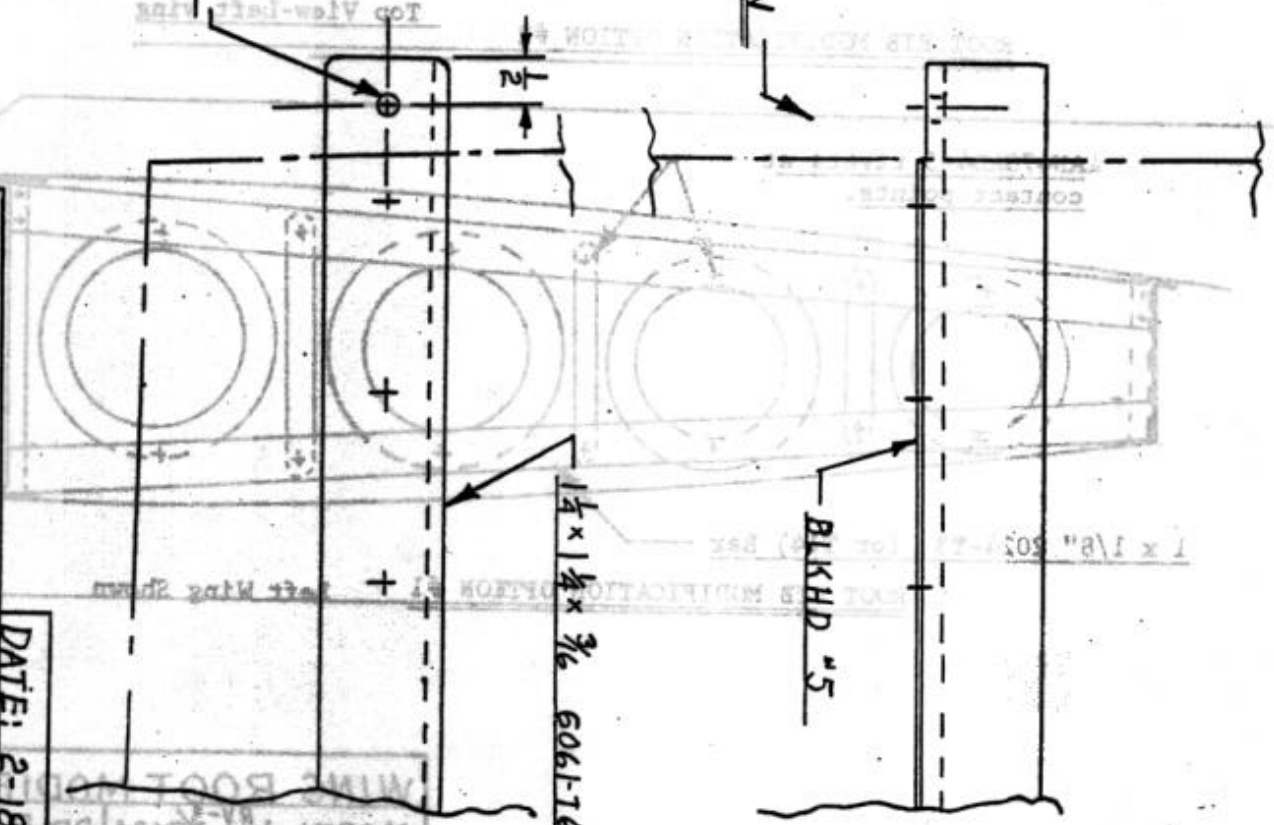
VAN'S AIRCRAFT DWG # C.N.I.-3

CN-1-3 details rear spar and center section modifications for RV-3s built from plans and kits supplied after Sept. 1980. These are distinguished by rear spar center sections of 1½ x 1½ x 3/16" 6061-T6 aluminum angle.

For RV-3 plans and kits supplied after Sept. 1980, a heavier center section spar was provided. (1 1/2 x 1 1/2 x 3/16 6061-T6 angle) This member needs no reinforcement, but the rear spar root plate must be modified per CN-1-3 to place the bolt in double shear. Modification of the rear spar root should be done in conjunction with the root rib modifications detailed on CN-1-2 and CN-1-4.

Two points of importance in this modification are the bolt hole edge distance mentioned above, and that the hole be such that it provide a snug fit for the bolt. Final drilling of the hole with a "D" drill will provide the desired fit.

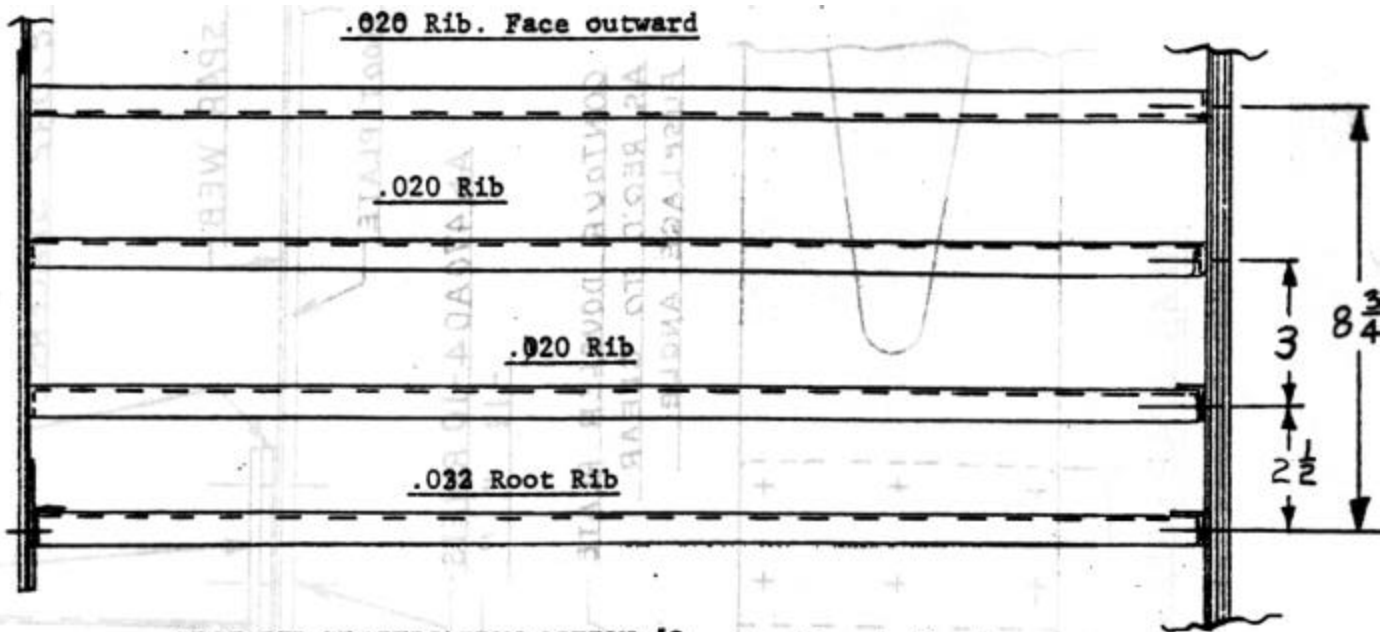
ROOT RIB MODIFICATION OPTION #3 Top View-Left wing

Options #2 and #3 are suggested for modifications being done on wings in early stages of construction, or at least those being done before the final (top) wing skins is riveted on. Of these, Option #3 is probably the best because it more effectively stiffens the skin of the inboard wing, and also permits the builder to simplify wing walk construction.

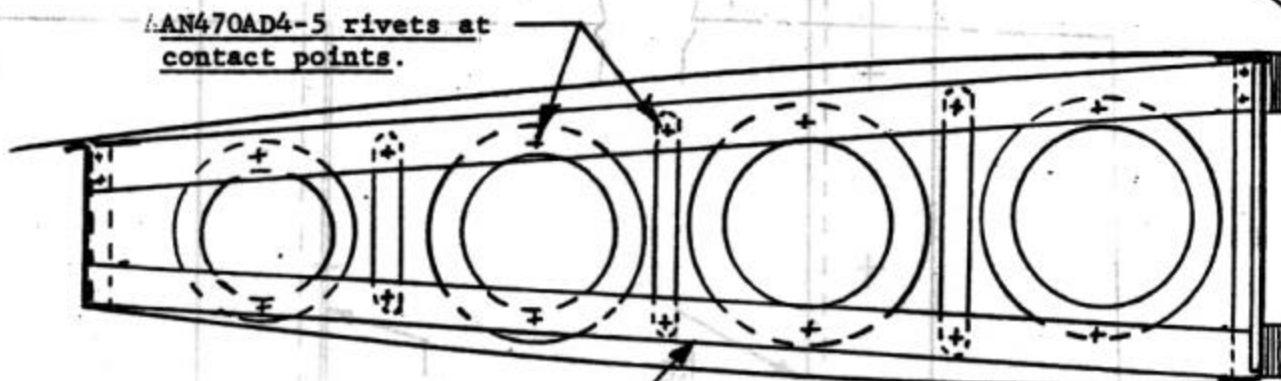
ROOT RIB MODIFICATION OPTION #1 Left Wing Shown

CN-1-4 details wing root rib modifications which can be performed on RV-3s of varying vintages. Option #1 applies to all vintages or degrees of completion. Option #2 and #3 apply to new RV-3 construction projects and to all inprogress RV-3 wings which have not yet had the final (top) skins riveted on.
