MANDATORY WING SPAR MODIFICATION FOR AEROBATIC FLIGHT

Document: CHANGE NOTICE #2 TYPE I (CN-2-I)

Model: RV-3, RV-3A

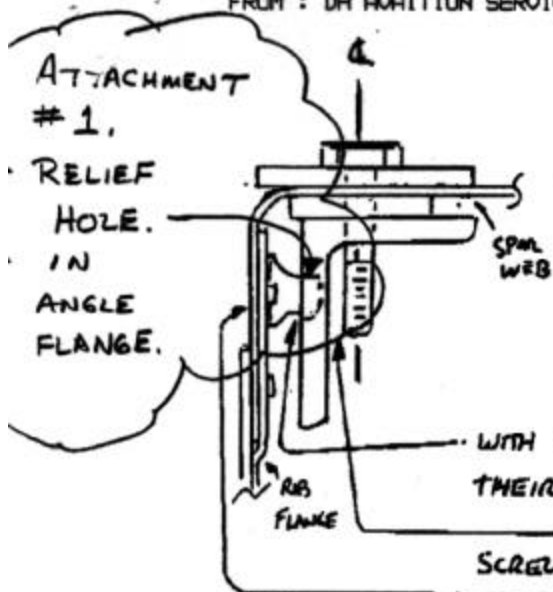
THE PROBLEM !

WITH ANGLE HARD UP AGAINST A NUT FOR TANK :-
 THERE IS NOT ENOUGH ROOM TO FIT NUTS AND
 SCREWS FOR TANK.

In an effort to keep the horizontal flange of the angle as close to where it was located during our static tests (as shown on the CN-2-3 drawings), drill a relief hole (see attachment 1) at the points of interference with the platenuts. This relief hole in the 1/8 x 1 x 1 1/4 angle should be no deeper nor larger in diameter than necessary. This will allow the angle to be moved closed to the spar flange so that a nut may be installed.

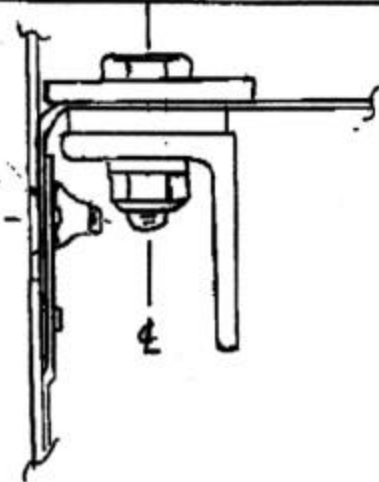
THE FIX ?

WHEN FITTING SPAR MOD CN-2-3 TO
 MY RV-3 I FOUND I HAVE THIS PROBLEM. IF
 I TURN THE ANGLE THE FIX WORKS. (ST 22 AND OTB ONLY).

The design you suggested would also stiffen the spar. However, since we have not tested the spar in this configuration we cannot tell you how effective this would be. If you don't like our suggestion, yours will probably work, just how well we cannot say.
